Elland Station Access Package Stage 1 Road Safety Audit

November 2021 (Initial Issue)

Prepared on behalf of Calderdale Council

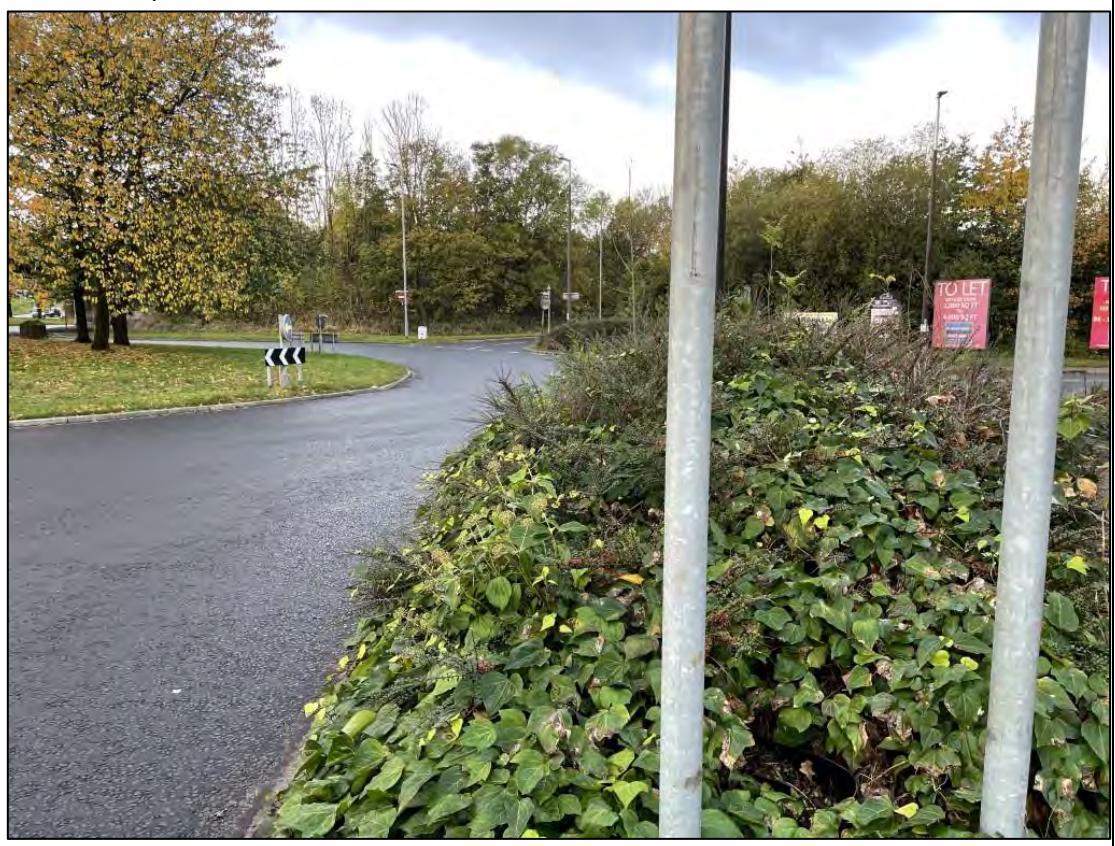
Table 2.10 Problem 10

PROBLEM	
Location	Lowfield Way
Summary	Existing vegetation restricts visibility to the west for pedestrians/cyclists crossing Elland Riorges Link.

Existing vegetation located between Lowfields Way and Elland Riorges Link restricts visibility to the west for pedestrians and cyclists wishing to cross Elland Riorges Link (west to east). The limited visibility increases the potential for users of the crossing being struck by vehicles turning left out of Lowfields Way.

Recommendation

It is recommended that the existing vegetation is cut back/reduced in height and appropriately maintained to provide suitable visibility from the western crossing position.

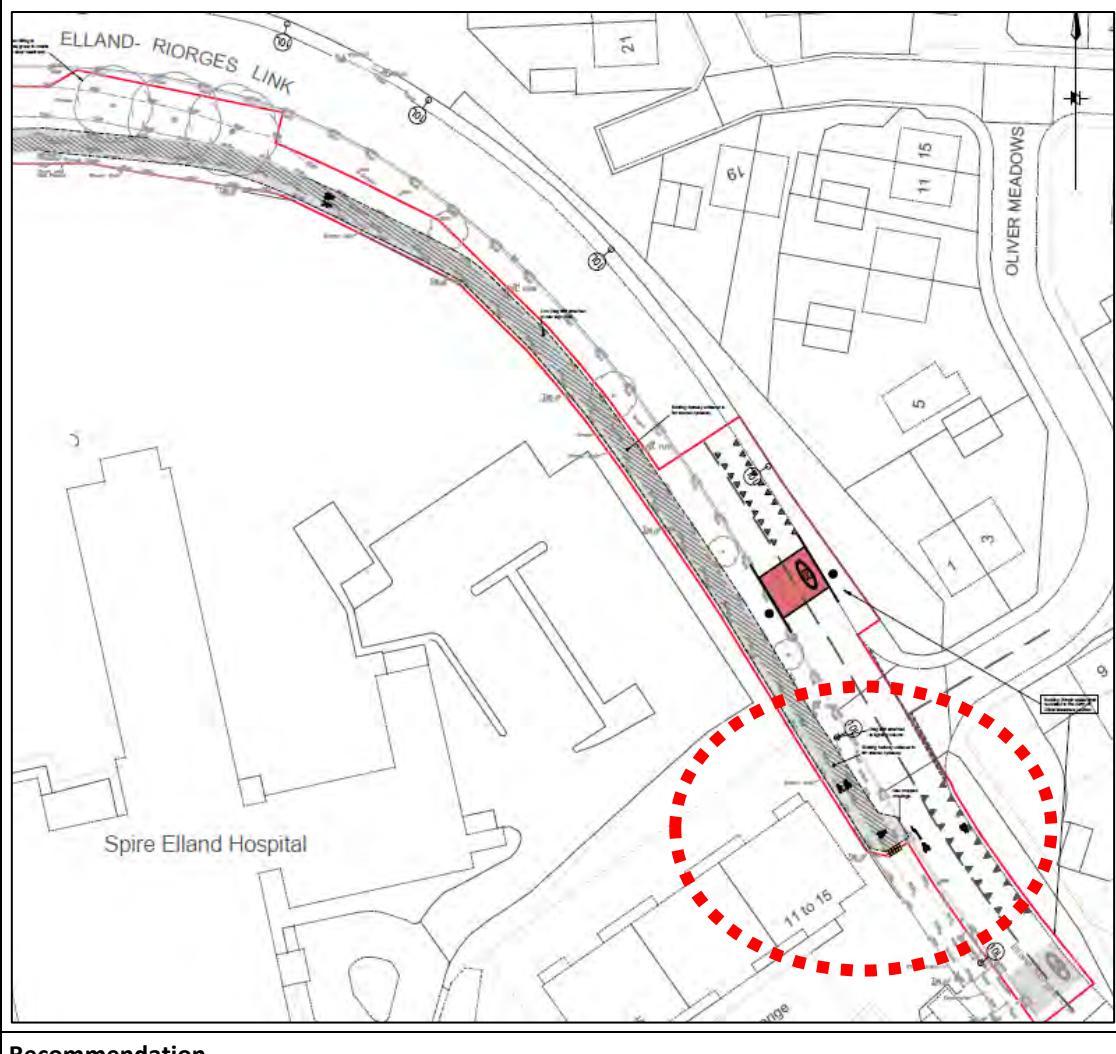
Table 2.13 Problem 13

PROBLEM	
Location	Elland Riorges Link/Lower Edge Road
Summary	The proposed cycleway may encourage eastbound cyclists to discharge into oncoming traffic.

A new cycleway is provided along the southern flank of Elland Riorges Link, which terminates opposite Oliver Meadows. The cycleway is bidirectional, therefore cyclists travelling eastbound away from the station are required to re-join the carriageway. In the absence of cycle lane give way markings and associated signage, cyclists may enter the carriageway in error, into the path of westbound traffic.

Recommendation

It is recommended that suitable give way markings and signage is provided to inform eastbound users of the cycleway.

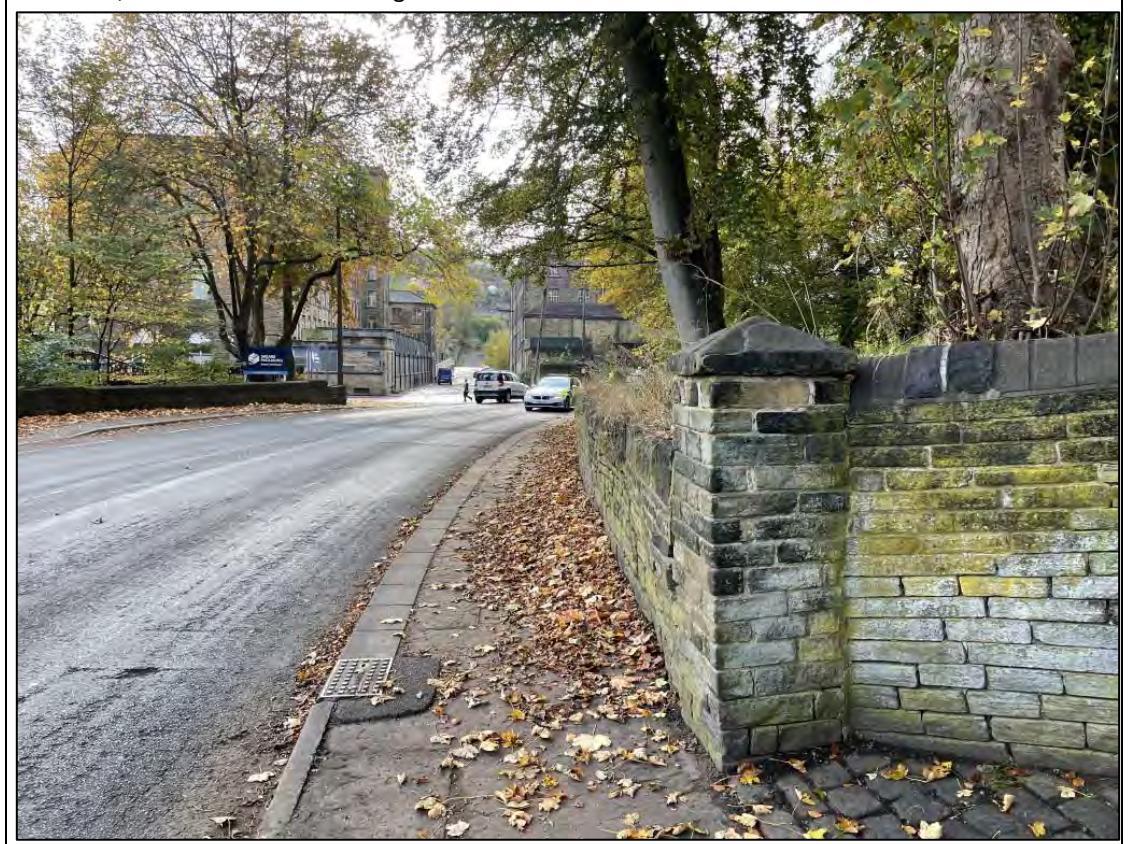
Table 2.14 Problem 14

PROBLEM	
Location	Stainland Road
Summary	The proposed crossing may increase the potential for a collision with a crossing pedestrian or rear shunts due to sudden braking.

A new signalised crossing is proposed to connect Clay House Park with Black Brook cycleway. The crossing is located on the inside of a bend along Stainland Road with restricted visibility due to the presence of a high retaining wall and existing vegetation along the boundary of Clay House. As a result, forward visibility for northbound vehicles, and pedestrian visibility southbound is

restricted, as illustrated on the image below.

Insufficient visibility for pedestrians to be able to see and be seen may lead to pedestrians being struck by oncoming traffic.

Recommendation

It is recommended that speed surveys are undertaken to determine whether appropriate forward visibility can be achieved. In the event that insufficient visibility can be achieved, it is recommended that either the crossing is relocated to a more appropriate location or additional measures are introduced to ensure approach speeds are reduced to justify a reduced visibility distance.

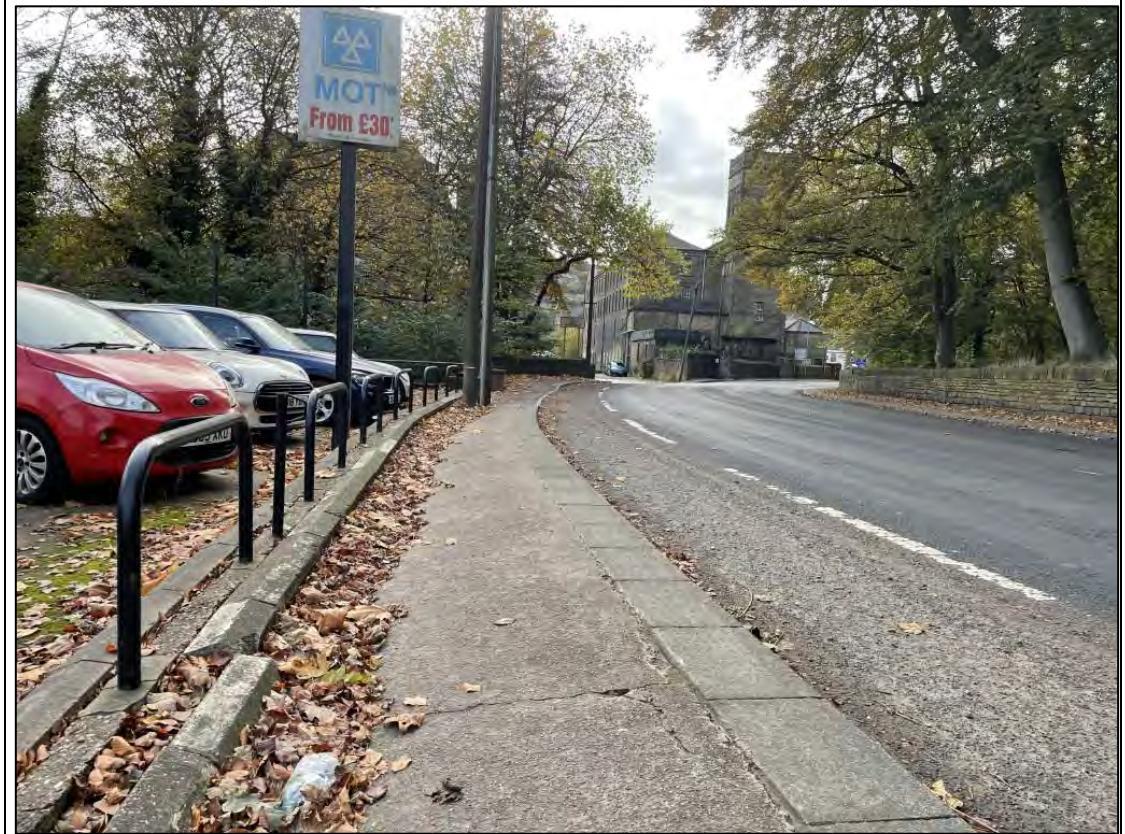
Table 2.15 Problem 15

PROBLEM	
Location	Stainland Road
Summary	Excessive footway crossfall may lead to pedestrian slips/falls and difficulty for partially sighted, blind and wheelchair users.

The existing footway along the eastern flank of Stainland Road is subject to a steep crossfall, that appears to exceed the recommended crossfall of 1 in 40 (2.5%) as illustrated on the image below.

It is noted that this footway will be widened to 2.0m, however no cross sections have been supplied confirming whether the footway crossfall is to be improved.

Retaining the current crossfall may contribute to pedestrian slips/falls, particularly during poor weather conditions and difficulty for partially sighted, blind and wheelchair users.

Recommendation

It is recommended that the footway is reprofiled in order to achieve a maximum crossfall of 1 in 40.
